A History of the Rockville Chapter Lake Repairs in 1981

By Miles A. Greenbaum

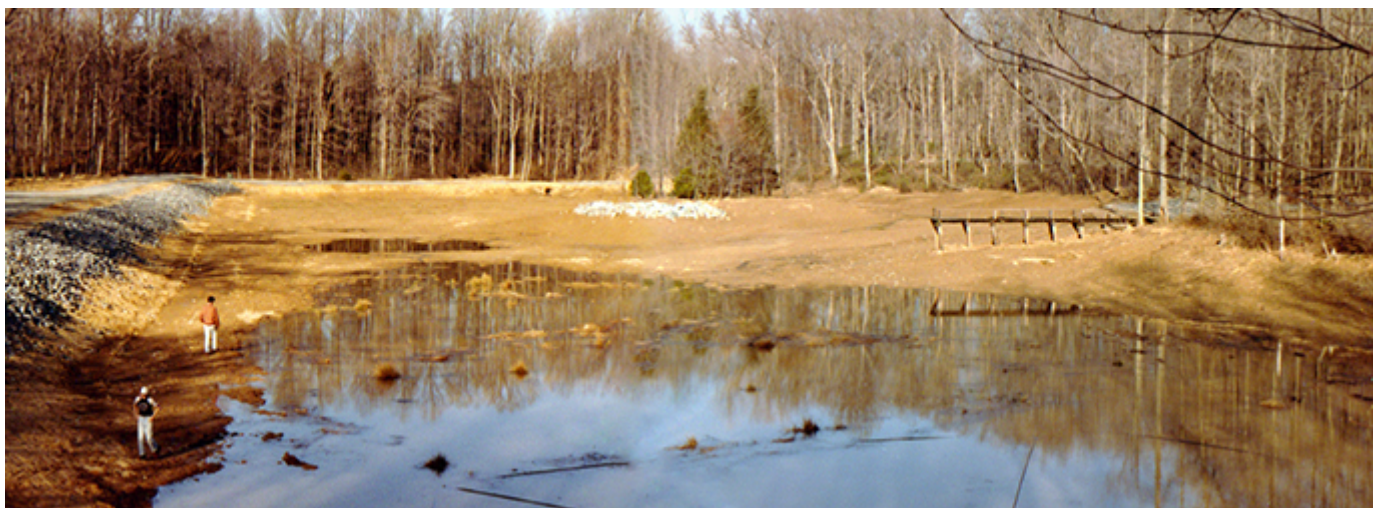
Actual work on the lake and dam repair started in February 1981. Over the years, a great deal of silt had accumulated in the lake and once the lake had drained and dried sufficiently, John arranged with a friend of his to come in and dredge the lake using a D-6 bulldozer. John had some really good friends, and we were only charged the cost of the diesel fuel. Vic Ezerski estimates that at completion of dredging, the depth of the lake was about 14 feet at the deepest point.

John Garner also arranged with another friend of his to obtain several dump trucks full of blue clay from West Virginia with which to line the lake to prevent leaks. Similarly, truckloads of rip-rap were used to line the lake side of the refurbished dam to prevent further incursions by musk rats or other invasive critters. Rocks and broken concrete were used to minimize erosion from high water on the Seneca Creek side. All the spoils from dredging the lake were used to fill in the entire area that is now the field behind the pavilion.
